MAC/MPC Programmer Modification

This modification intended to address the issue with CONTINENTAL airbag units from RENAULT / DACIA based on SPC560P50 chip.

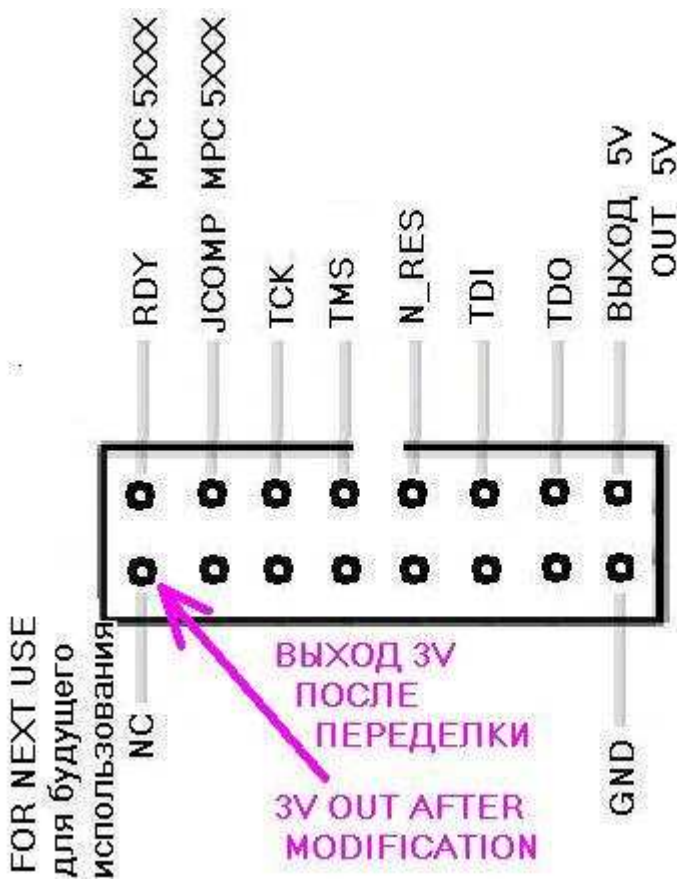
Here is a connector pinout with a new +3V OUT pin:

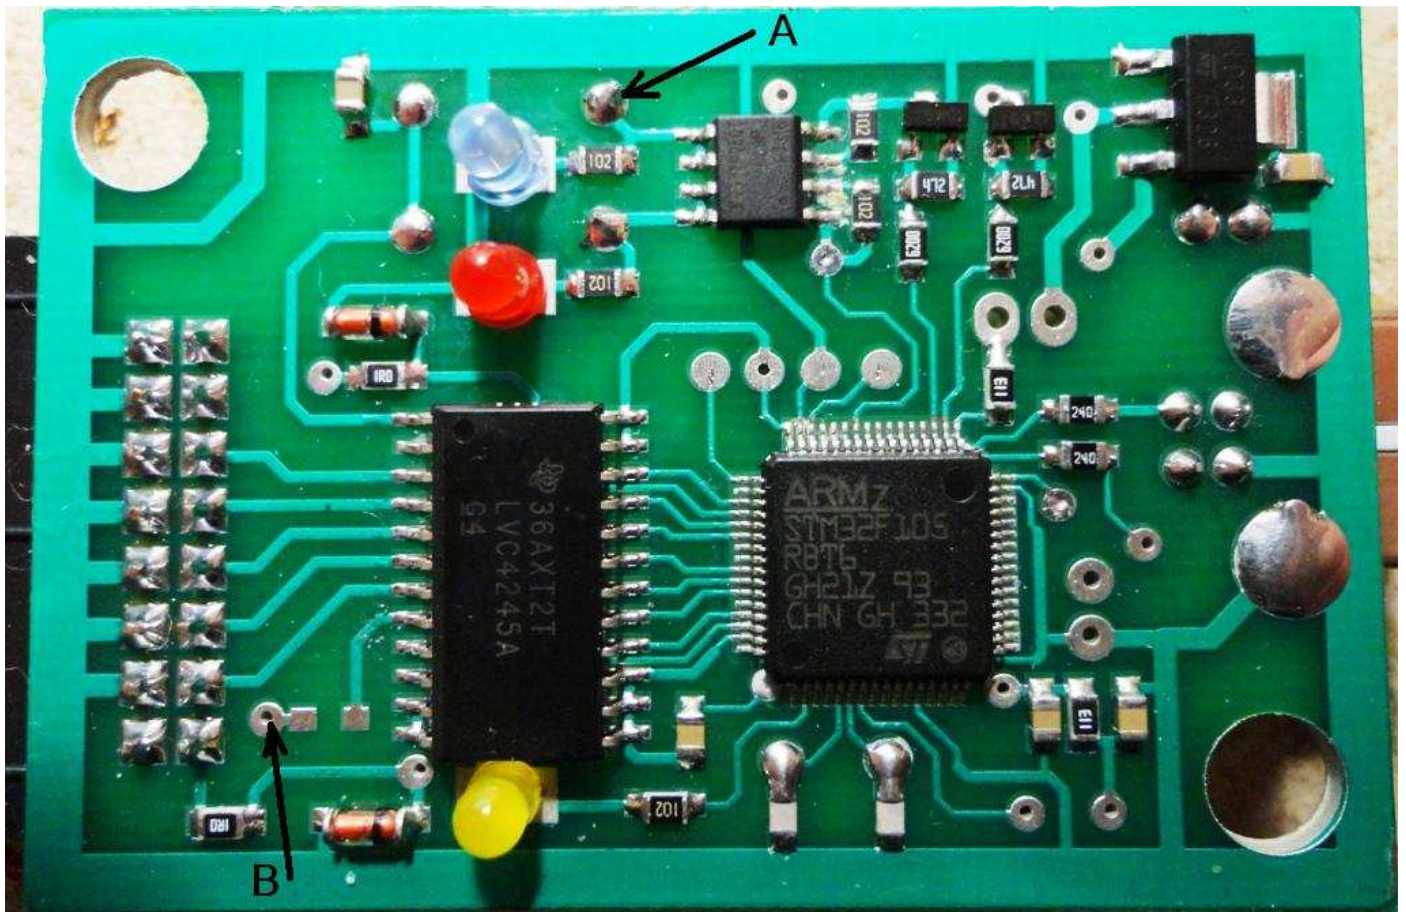
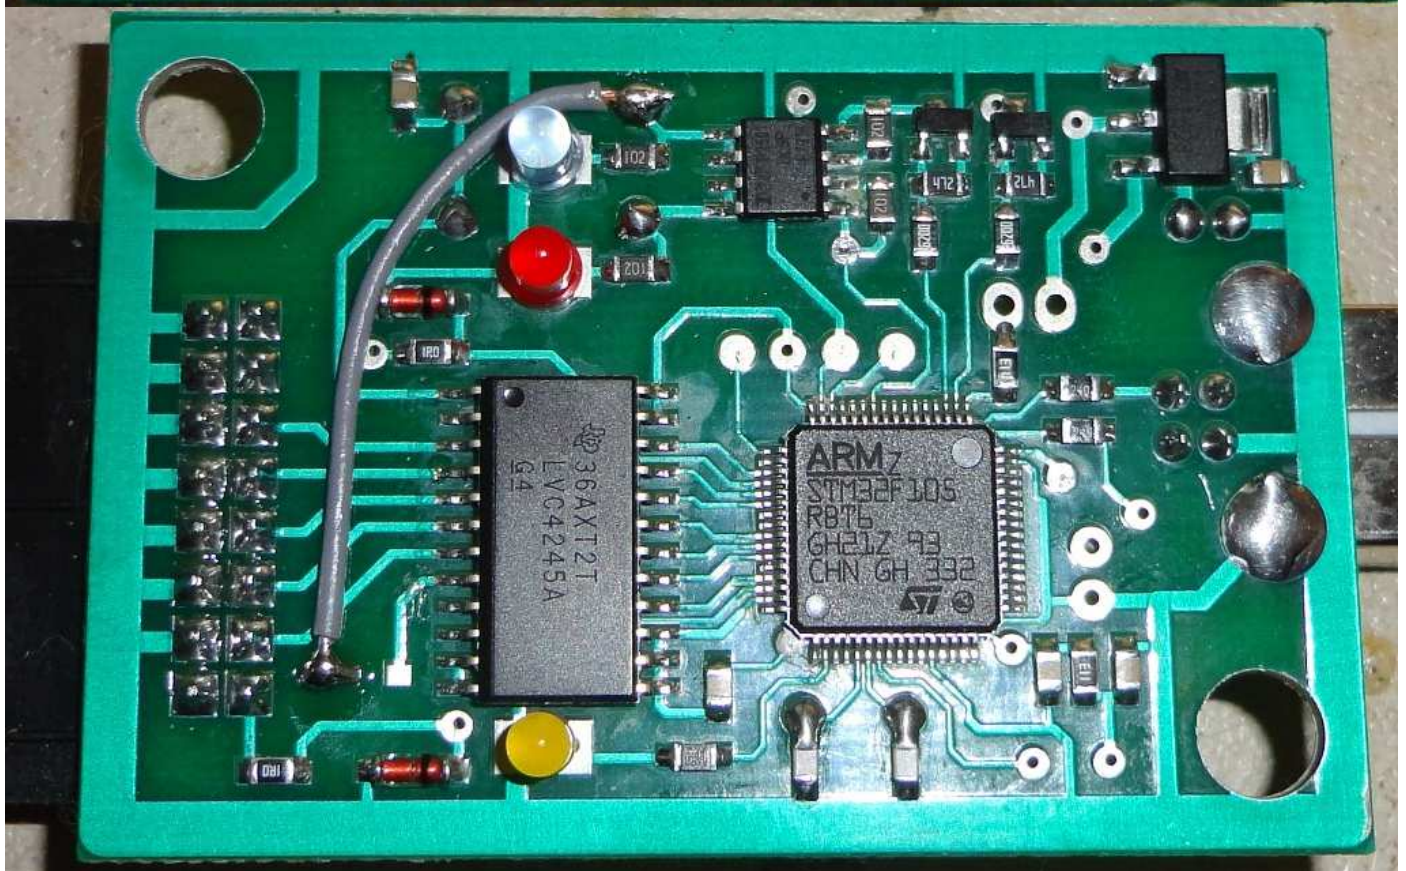
Points A and B before and after connection:

Modification transforms previously unused pin into +3V output in the connector. For modification you need to open programmer's case, extract the PCB and connect points A and B with a wire as pictured.

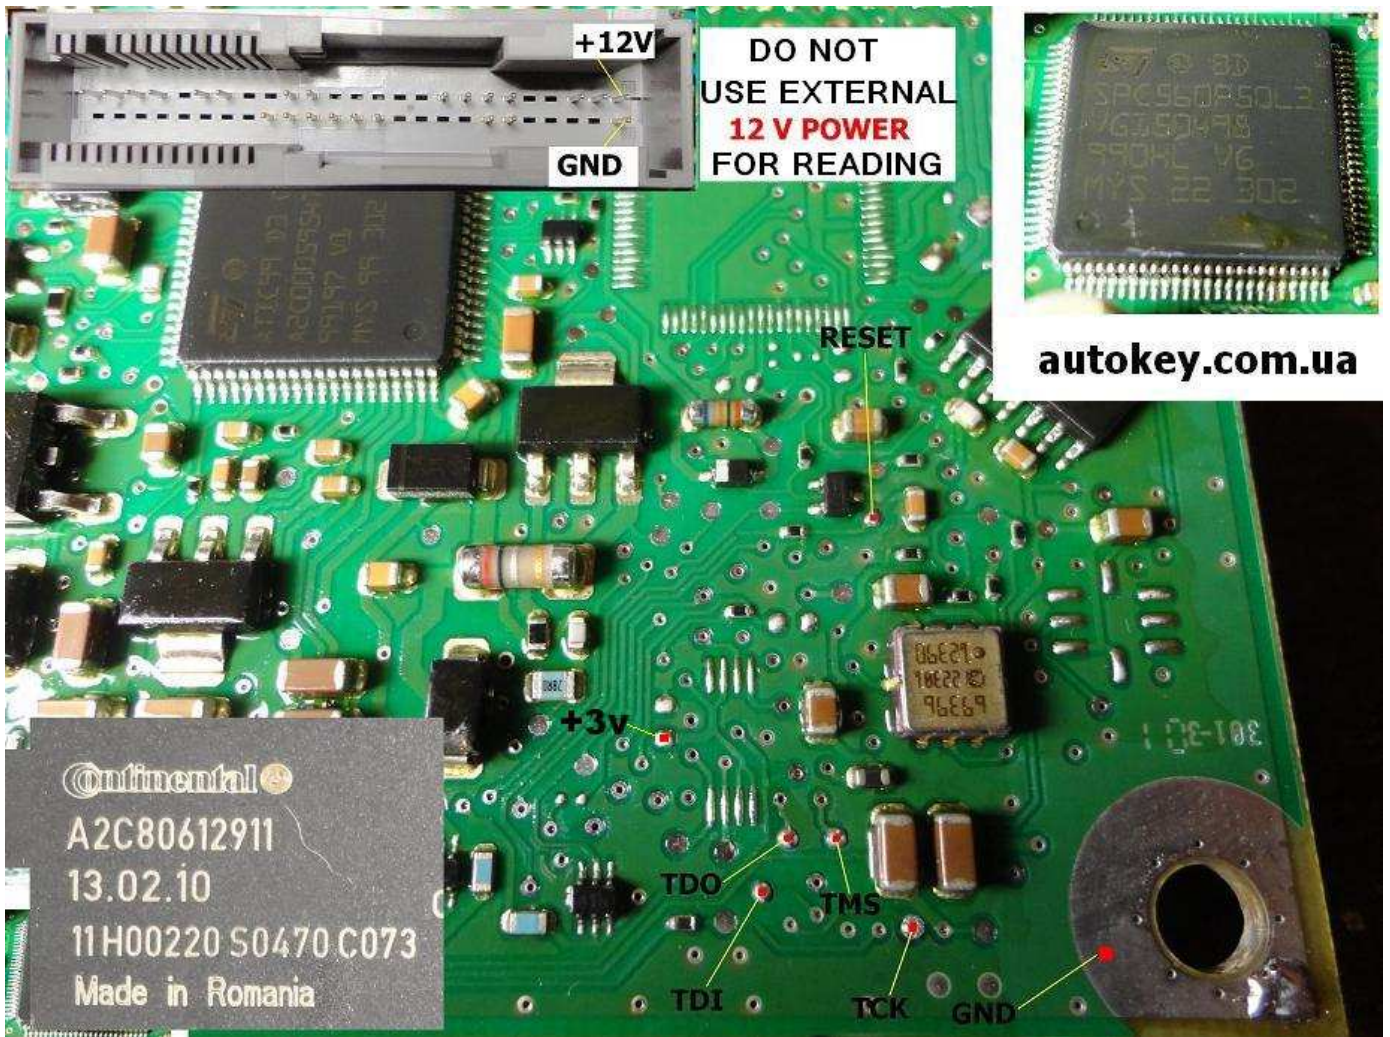
Now programmer can supply +3V power to the unit automatically. Updated connection diagram is shown below. Note that you shouldn't supply external +12V for reading.

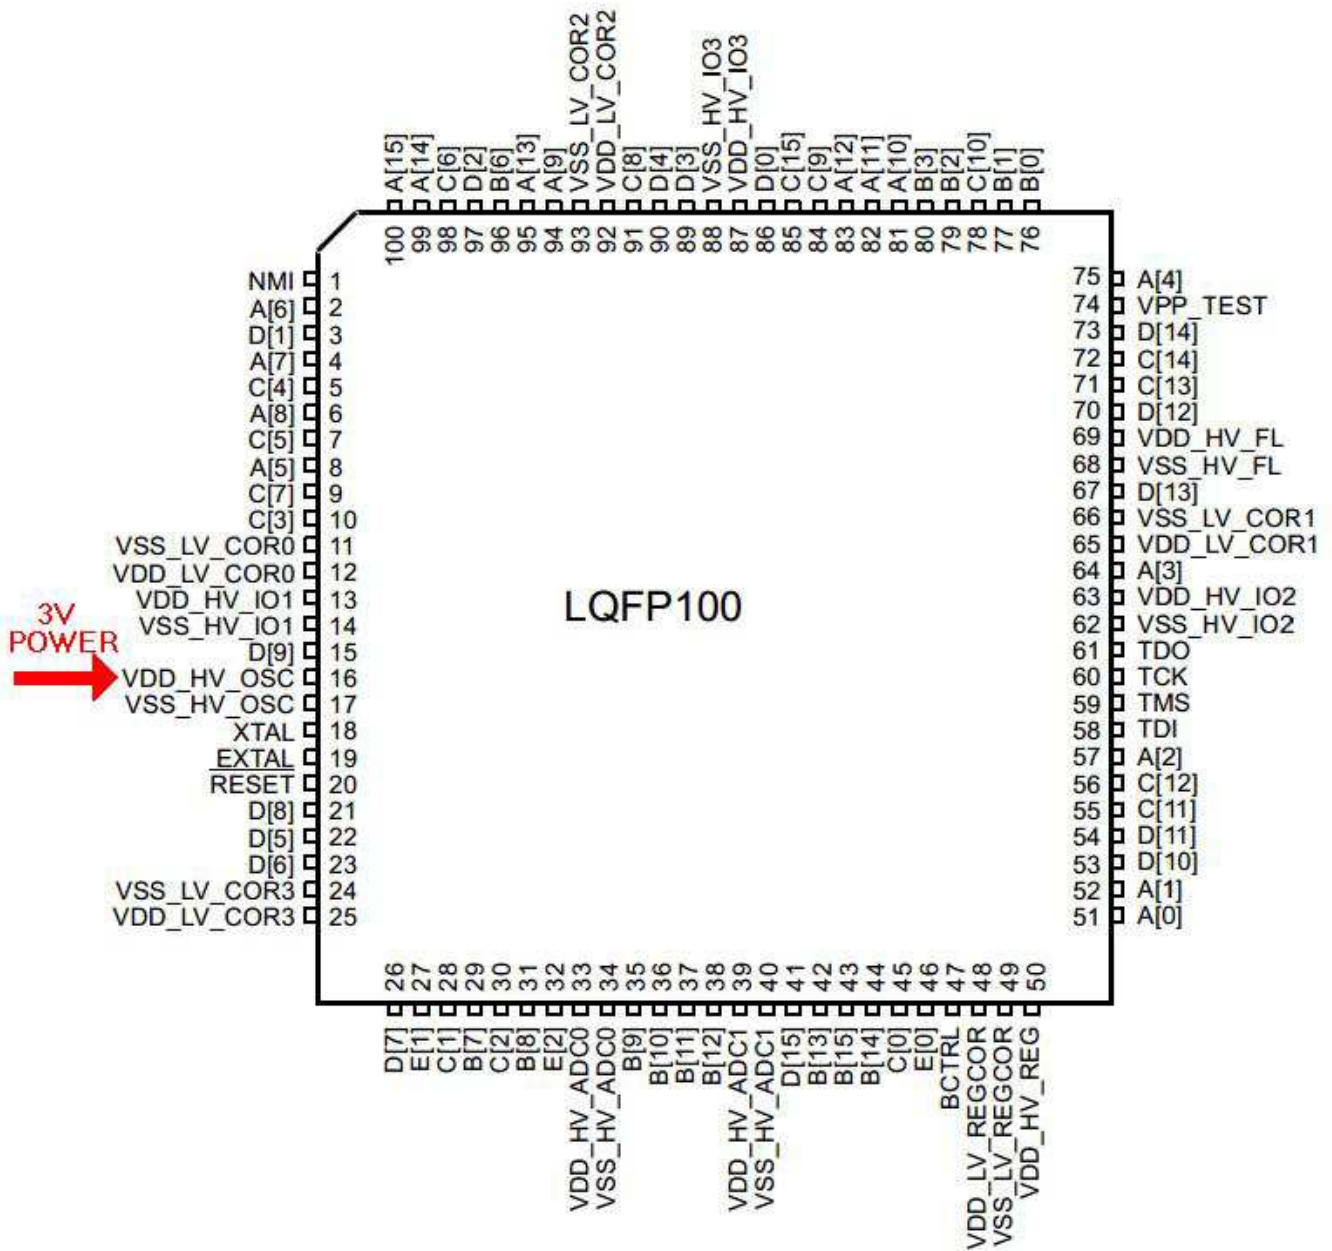
Here is how +3V supplied to the MCU:
